Israeli Offensive on Lebanon 2023-2024

Overview of Attacks and Damages Across Key Sectors

The National Council for Scientific Research
National Center for Natural Hazards and Early Warning

Beirut on 10/12/2024

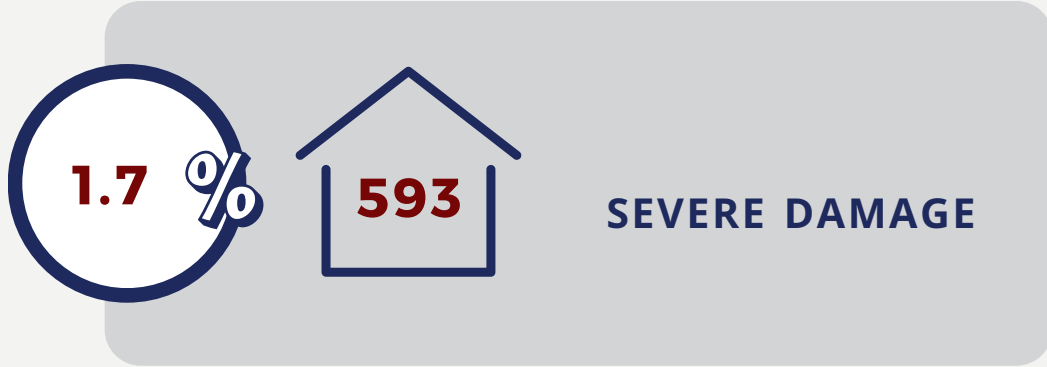
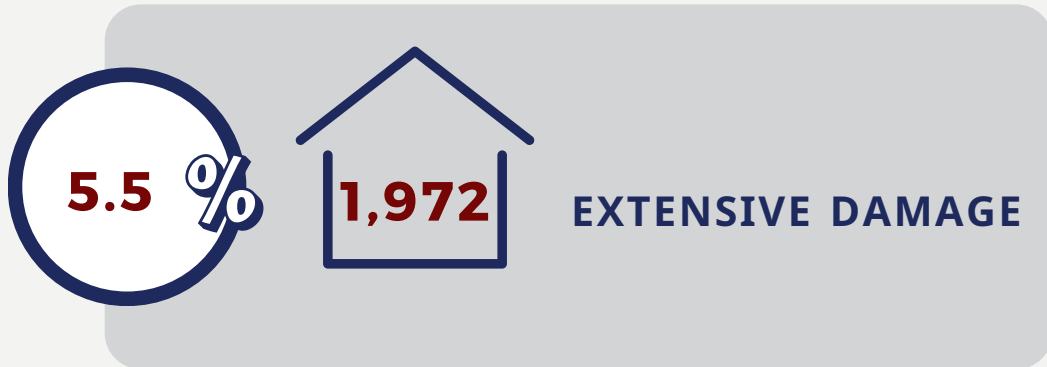
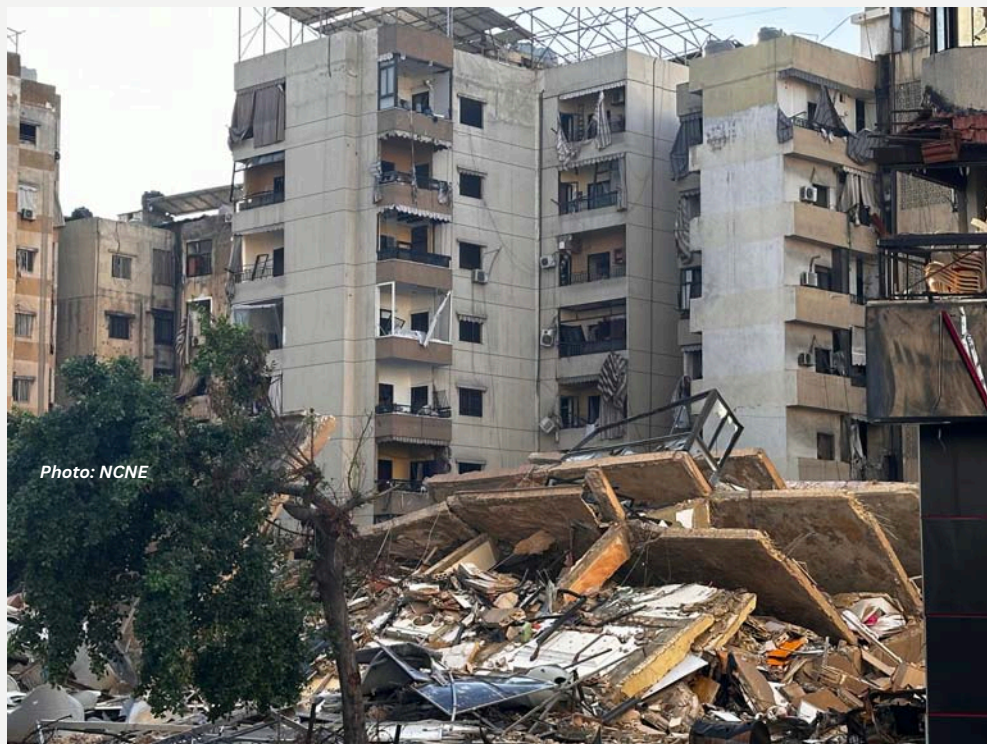
In the southern suburbs of Beirut, for example, since the beginning of the offensive on Lebanon, damage assessment through satellite imagery revealed the **complete destruction of 353 buildings**, representing **1% of the total number of buildings**. It is worth noting that this percentage includes only the buildings that were completely destroyed as a result of Israeli bombardment.

An estimate of the number of damaged buildings in the Southern Suburbs of Beirut by severity of damage

It is worth noting that estimates based on satellite images provide a preliminary assessment of the damages and require field surveys to obtain accurate final results.

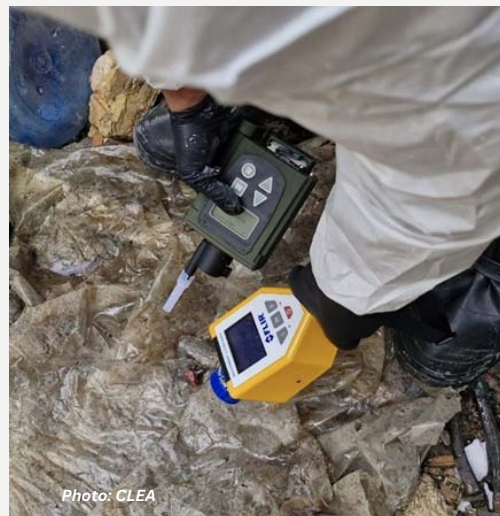
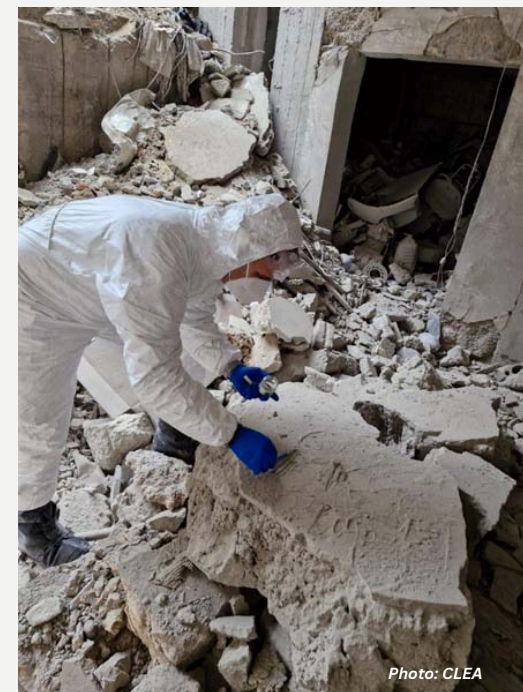
Figure 1: Photos of some of the sites from which samples were taken in the Southern Suburb of Beirut

A comprehensive radiological survey was carried out at these sites, resulting in the collection of 38 credible samples from missile craters and areas near the points of impact. The samples comprised **14 soil samples, 7 dust smear samples, 11 building debris samples, and 6 metal fragments from missile remnants.** These samples were meticulously analyzed in the laboratory, with key findings detailed in Figures 1 & 2.

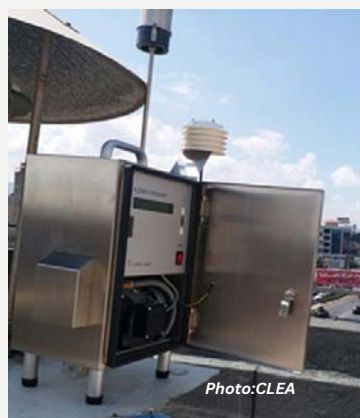
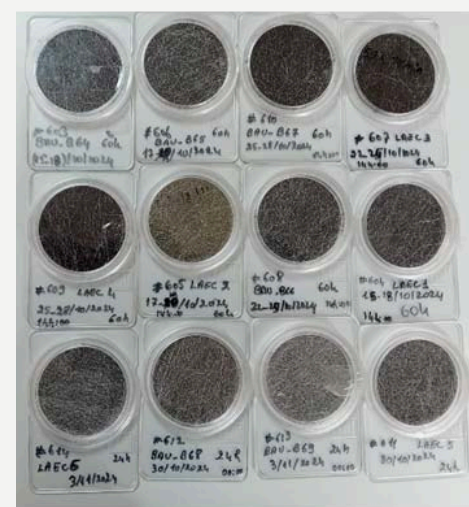
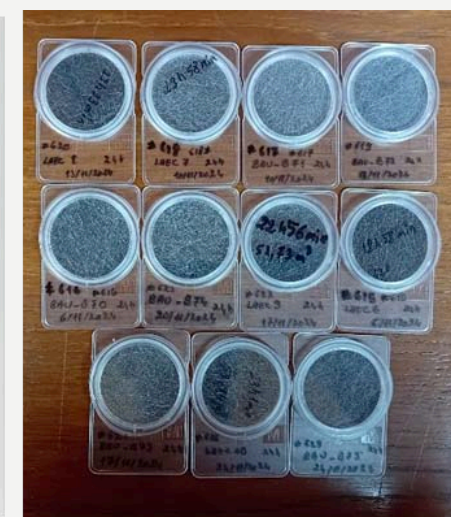
Figure 4: Air particulate sampling station in Ghobeiri and photos of some air particulate samples (PM-2.5) that were collected.

Figure 5: The X-ray fluorescence energy spectrum of a standard sample containing uranium salts (black) compared to the typical X-ray fluorescence energy spectrum of PM2.5 air particulate samples collected from the Ghobeiry area during the intensive bombardment of the southern suburbs (red). The logarithmic scale demonstrates the absence of any detectable traces of uranium in the air particulate samples.

Additionally, the Lebanese Atomic Energy Commission; Since October 15, 2024, has been conducting daily sampling of fine particulate matter (PM-2.5) from two locations: the Ghobeiry area in the southern suburbs of Beirut (Figure 4), and the Cola area in Beirut, approximately 2 kilometers away, designated as a reference site outside the targeted zones.

Elemental analyses were performed on **40 air particulate samples** collected from both sites. Within the detection limits of the applied analytical techniques, no traces of uranium were identified in any of the samples, as shown in Figure 5

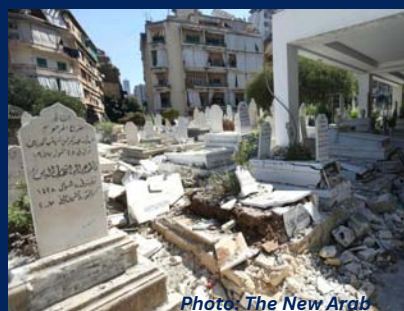
Bashoura Cemeteries

Additionally, damages were recorded due to indirect Israeli attacks near the cemeteries, causing significant damage. These include the Bashoura, Nabatieh, Majdal Selm, Harouf, Dhahira, Yaron, and Riak al-Fouqa cemeteries, and many others.

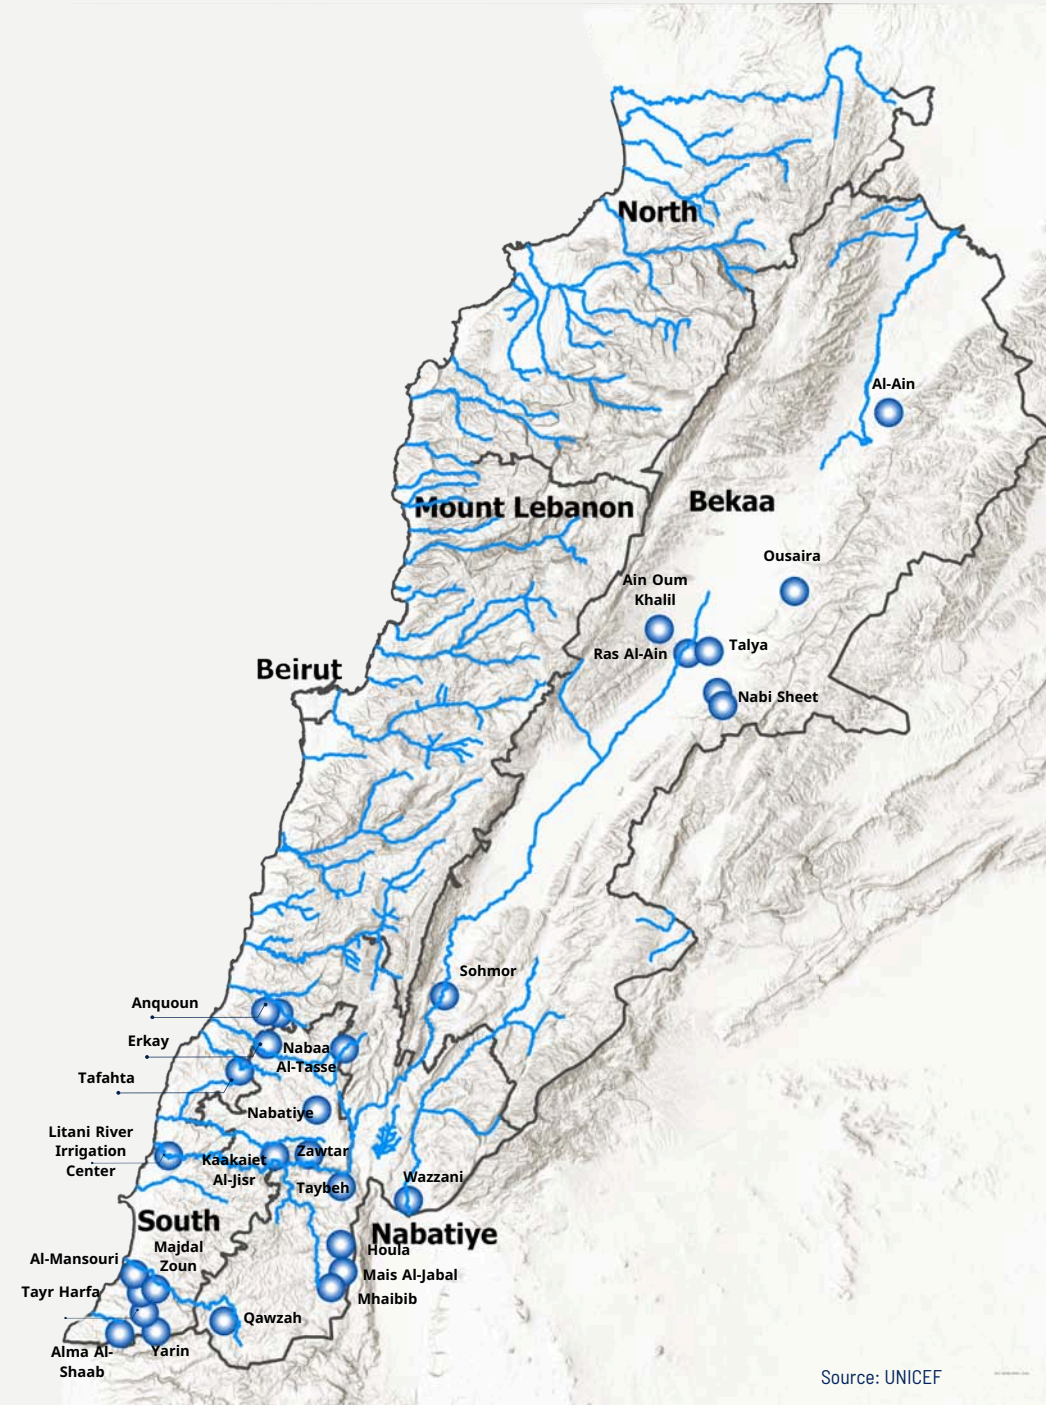
More than thirty water facilities were damaged as a result of the Israeli offensive on Lebanon from October 8, 2023, until the date of the ceasefire.

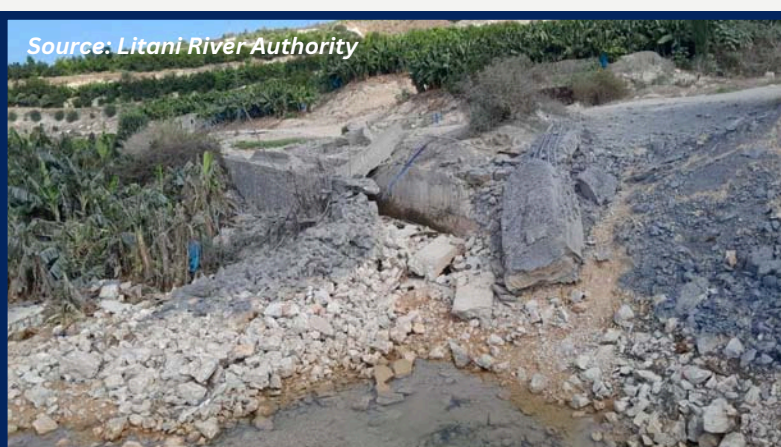
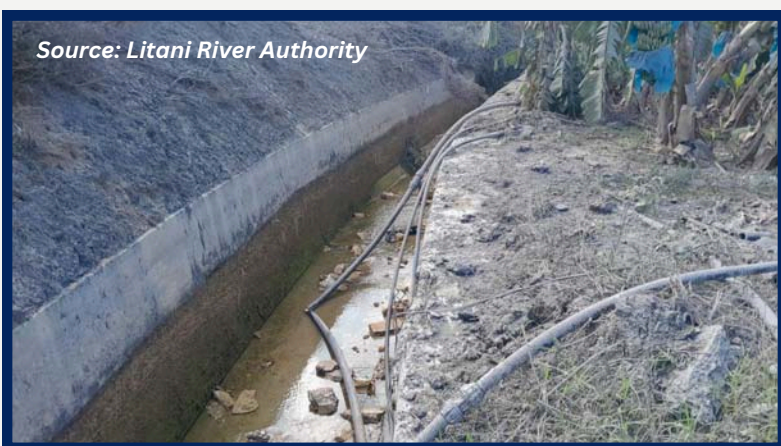
The main water carrier of the Litani River

The Litani River Authority announced that, based on the inspection results, maintenance teams began preparing the necessary machinery, equipment, and materials for urgent temporary repairs, particularly to the main water carrier along the canal in the Arzi area. This is to restore the operation of the canal and supply it with water, enabling farmers to irrigate their lands and protect their crops.

In response, the Litani River Authority has implemented temporary measures to divert water and prevent flooding of agricultural lands and roads. The authority is also taking the necessary steps to restore the project's operation and ensure the continued supply of water to agricultural lands.

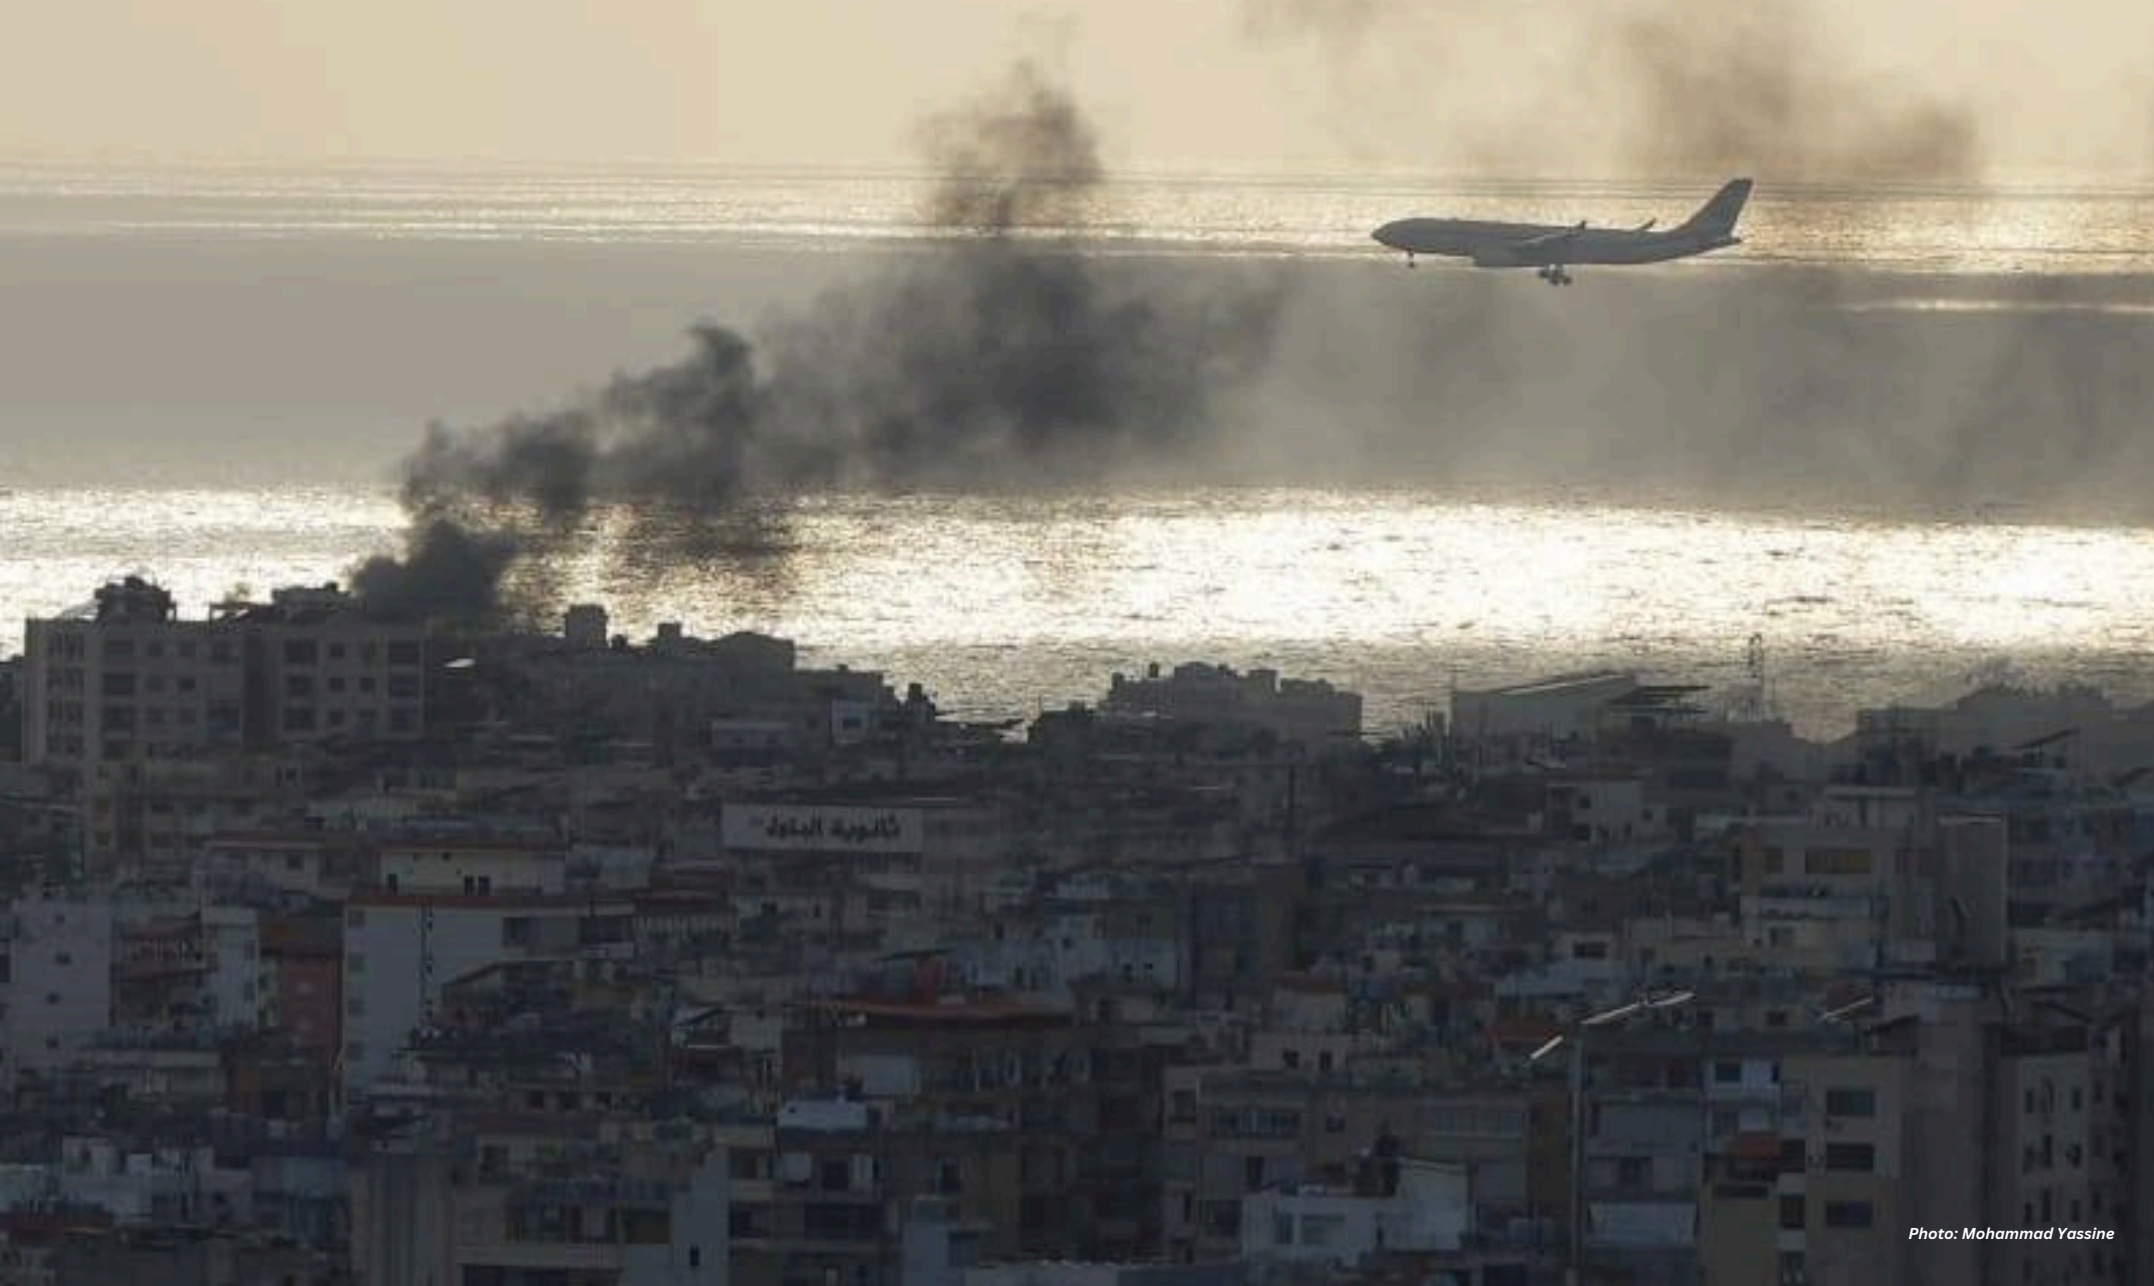
The vicinity of Rafic Hariri International Airport was targeted by several airstrikes, posing a threat to air navigation and causing material damage to the airport building. Furthermore, air traffic to and from Lebanon was significantly affected, as many airlines suspended their flights due to the Israeli Offensive.

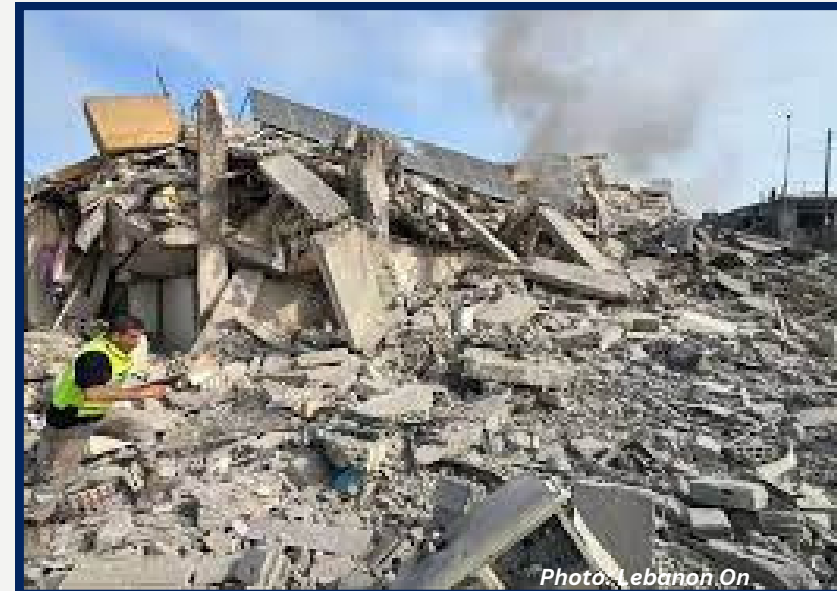
Direct targeting of the municipality building in Nabatieh, which led to the martyrdom of the mayor, several members of the municipal council, and civilian employees
